ALL BOAT & YACHT INSPECTIONS, LLC

PRE-PURCHASE CONDITION AND VALUATION SURVEY

ABYI File # 07XXX
Client John C. Boatbuyer
Mailing Address 123 Waterview Drive
..... Watertown, USA
Survey Date March 8, 2007

Vessel Name ***Planned Poverty***
Hailing Port Annapolis, MD
Year, Make & Model 1987 Bertram 46.6 Convertible motor vessel
Hull ID # BERXXXXXXXX87
Registration # USCG Documentation #XXXXXX
Registered Owner Joe Gearhead
Hull Length 46' 6"
Beam 16' 0"
Draft 4' 6"
Displacement 45,000#
Hull Material Fiberglass composite
Fuel Type Diesel
Top Speed 27 Knots
Intended Areas of Navigation Coastal, Bays & Tributaries

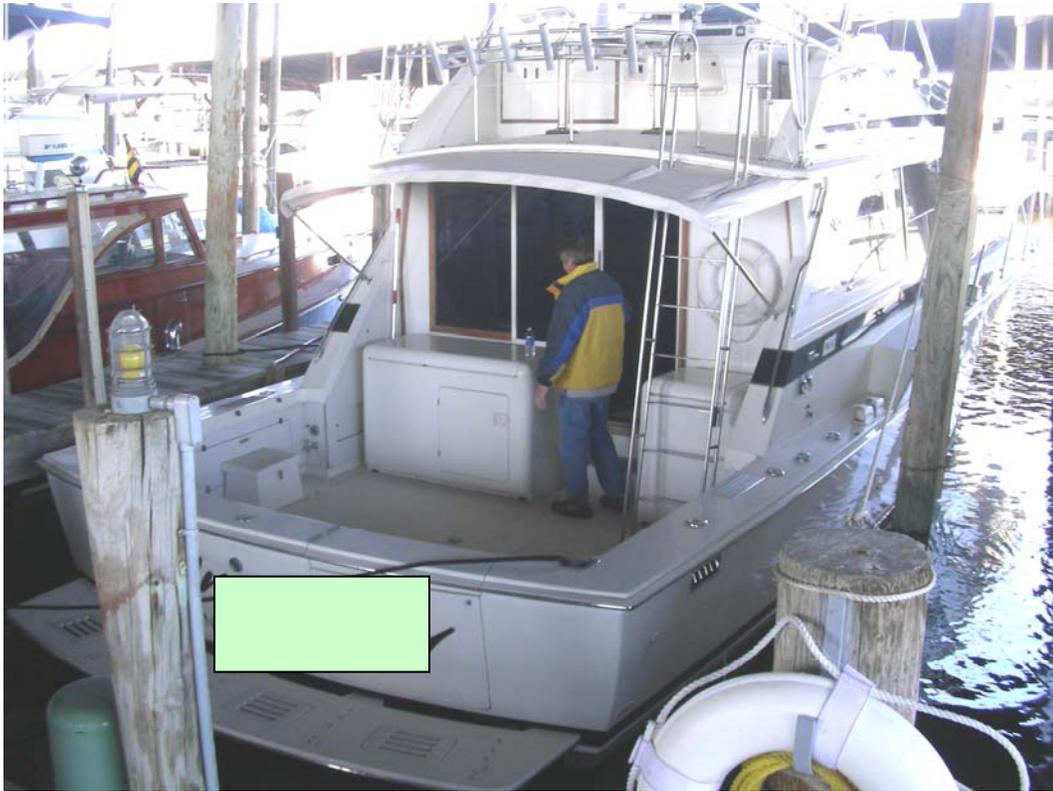
Photograph of the **Planned Poverty** as seen from the starboard stern quarter, taken at the time of survey on March 8, 2007.

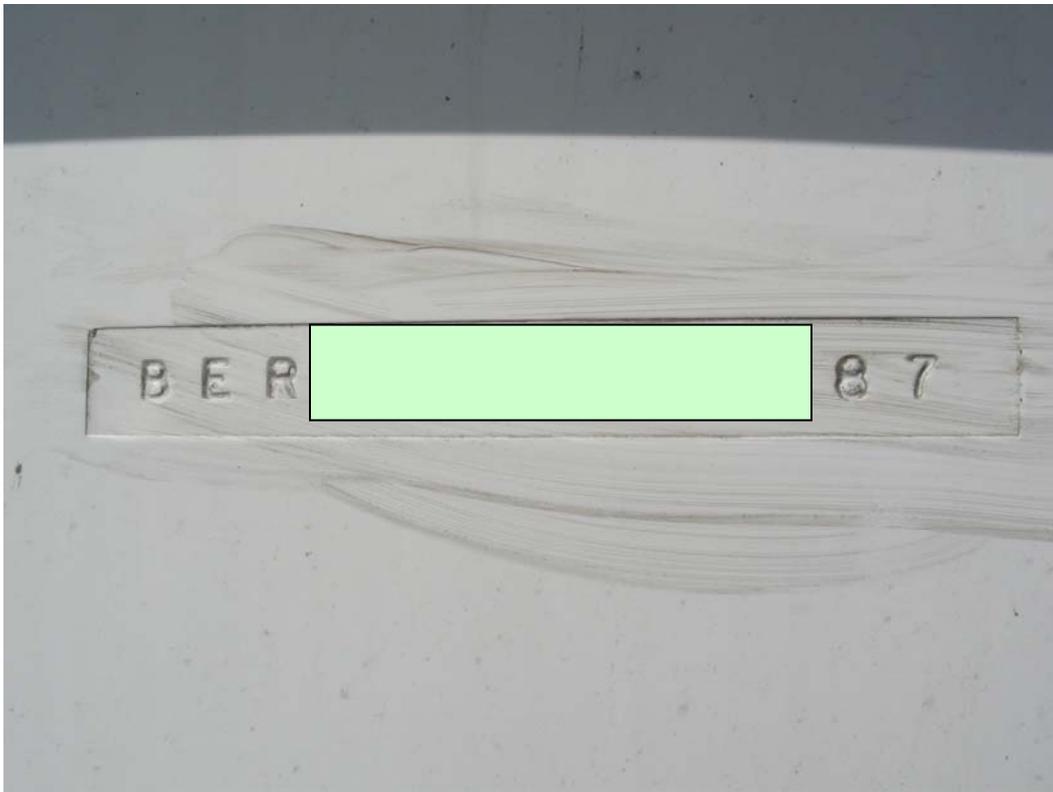
Photograph of the hull identification number located on the starboard side of the transom, taken at the time of survey on March 8, 2007.

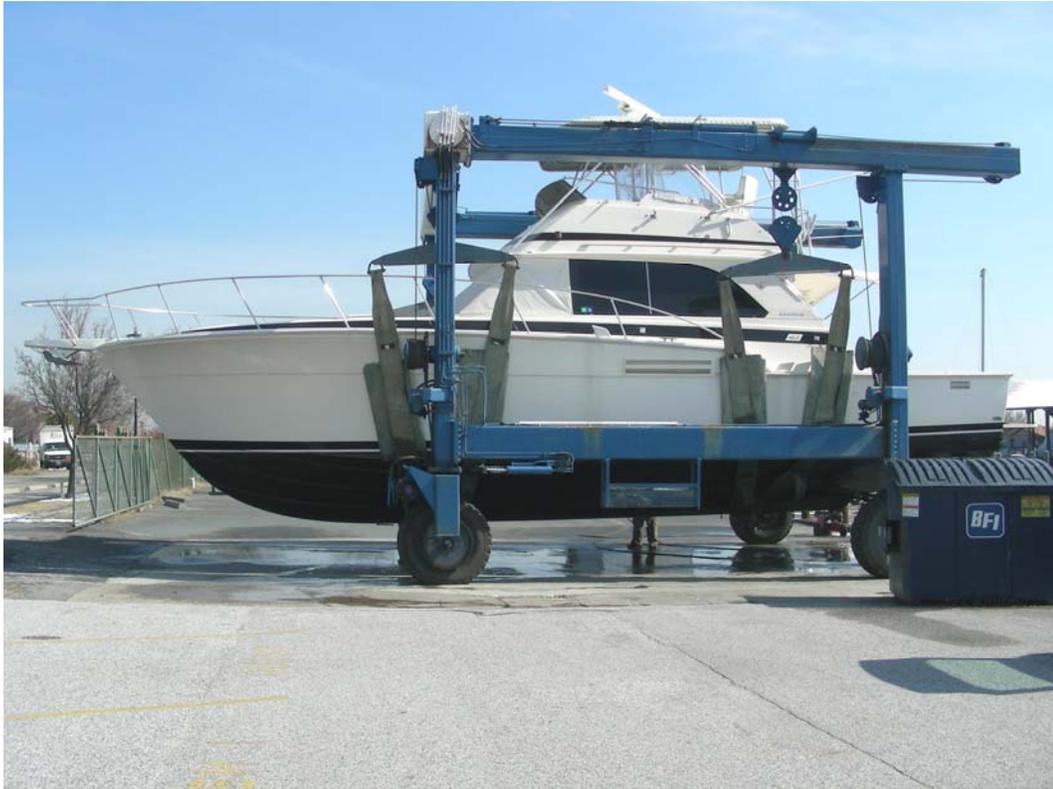
Photograph of the ***Planned Poverty*** as seen from the port beam, taken at the time of survey on March 8, 2007.

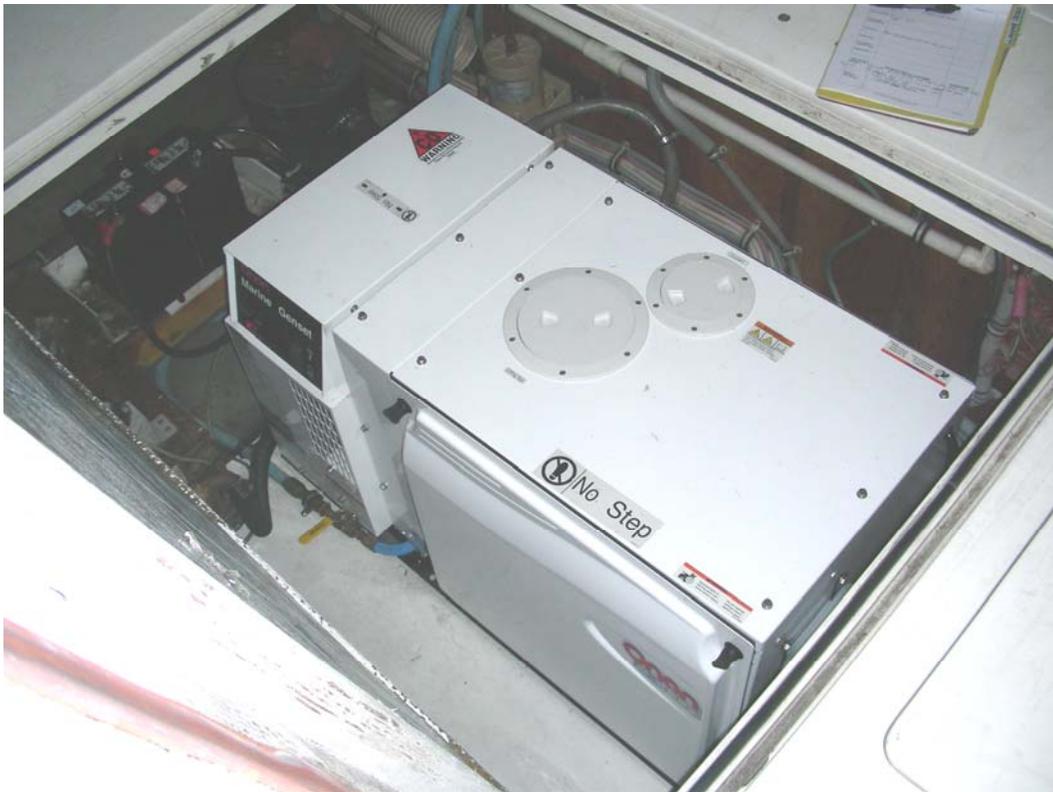
Photograph of the AC generator located beneath the cockpit deck as seen from the starboard corner of the cockpit, taken at the time of survey on March 8, 2007. The generator is reported to have been renewed in 2006.
