ALL BOAT & YACHT INSPECTIONS, LLC

PRE-PURCHASE CONDITION AND VALUATION SURVEY

Vessel Name **Summer Breeze**
Hailing Port Annapolis, MD
Year, Make & Model 1996 Beneteau 351 Sailboat
Hull ID # BEYXXXXXXXX96
Registration # USCG Documentation #XXXXXXX
Registered Owner Robert P. Calm
Hull Length 35'
Beam 12' 6"
Draft 5'
Displacement 12,000#
Hull Material Fiberglass composite
Fuel Type & Engine Horsepower Diesel – 27-hp
Top Speed (under power) 7 knots
Intended Areas of Navigation Long Island Sound & Coastal NE

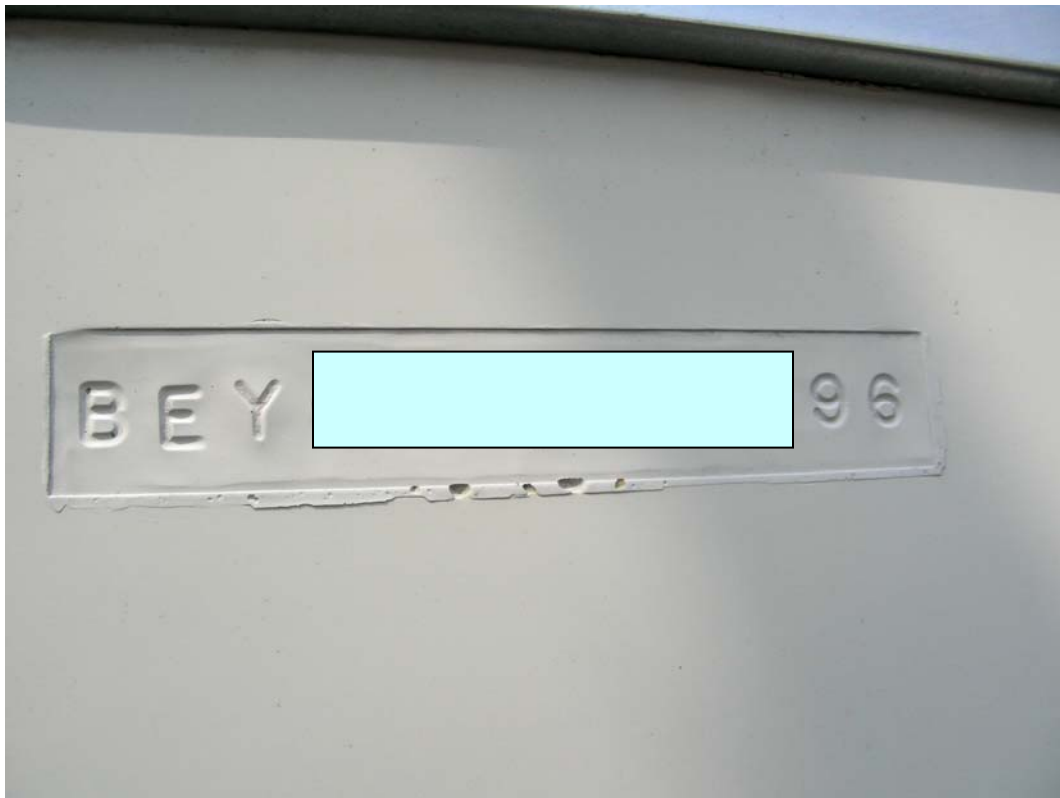
Photograph of the hull identification number located on the aft end of the starboard hull topsides, taken at the time of survey on June 8, 2007.
